Ballethnic Dance Company

2587 Cheney St East Point, GA 30344

PROJECT HIGHLIGHTS

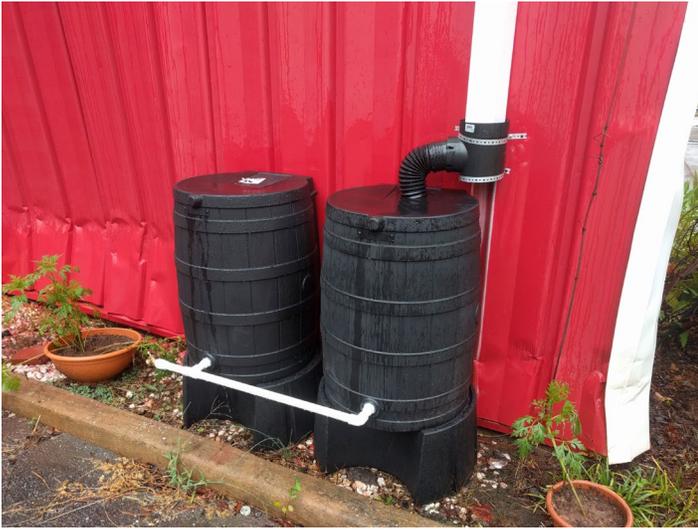
FIG. 1

Rainwater barrels for landscape irrigation. Decreases cost and usage of water on landscape irrigation.

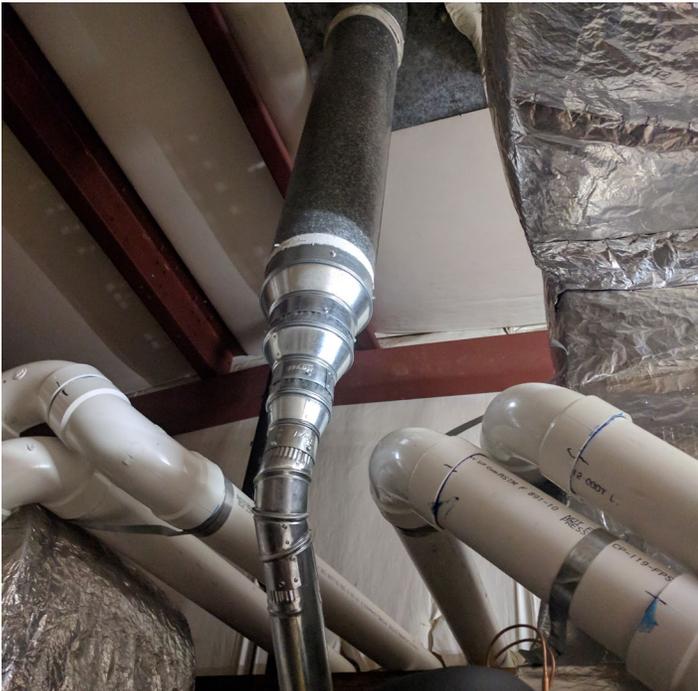
FIG. 2

Updated ductwork and HVAC system. Gaps sealed to prevent loss of regulated air. Old or broken parts of HVAC replaced with parts above standard building code.

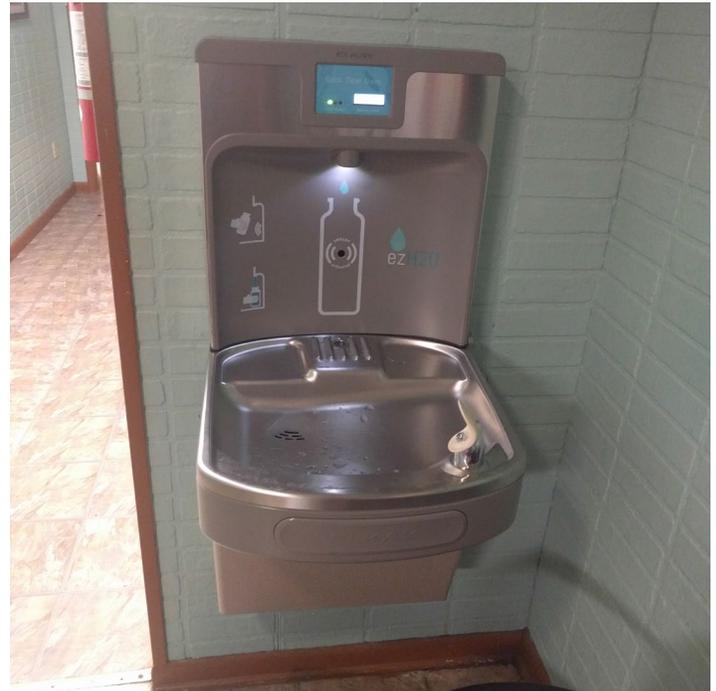
FIG. 4

High-efficiency water fountain. Motion sensor prevents excess water use. Supports reusable water bottles with easy refill.
