# GREENSTONE ON FIFTH

Greenstone on Fifth Community Building at Blue Ridge Apartments in Charlottesville, Virginia is a 3,531 square foot, two-story commercial building that was certified in the **EarthCraft Light Commercial (ECLC)** green building program in 2014. Greenstone on Fifth partnered with Southface to analyze building design and performance and identify areas for improvement through the U.S. Department of Energy-sponsored Advanced Commercial Buildings Initiative. Actual building performance data was collected with circuit-level energy monitors and temperature sensors deployed for one year post-occupancy. Southface studied hourly energy simulation modeling and building monitoring data to assess the actual performance of energy efficiency strategies implemented at Greenstone.

## Findings

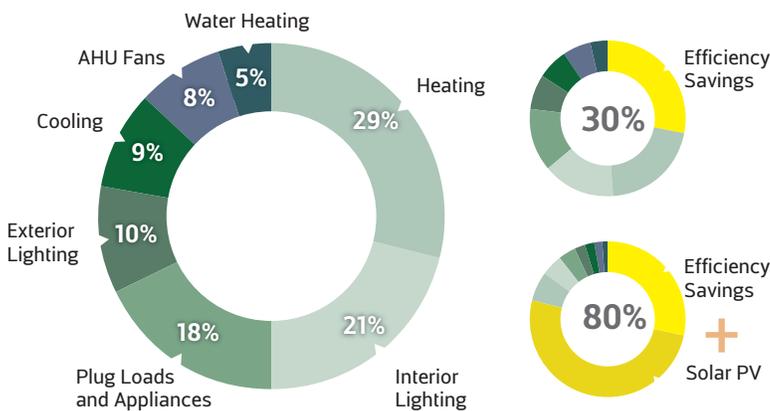
Figure 1. Energy use segmented by end-use and comparisons of Efficiency and Solar PV Savings added to the energy picture.

The all-electric Greenstone is currently **saving 30%** in electricity consumption relative to a code-equivalent building (*ASHRAE 90.1-2007*), without accounting for the installed rooftop solar photovoltaic (PV) array. Including the rooftop solar PV, Greenstone is **saving 80%** in electricity consumption relative to a code-equivalent building.

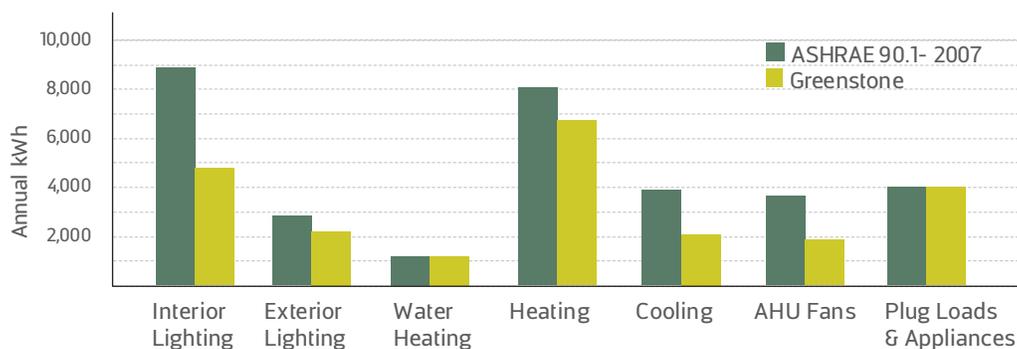
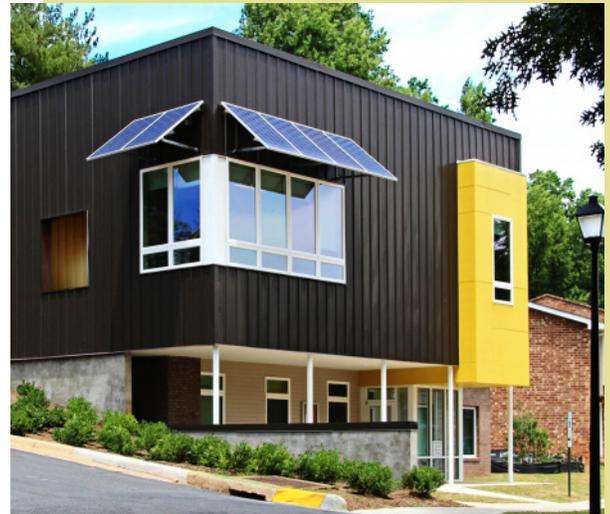
Figure 2. Overall efficiency savings are driven by reductions in interior lighting, cooling, air handler fans, heating, and exterior lighting energy use.

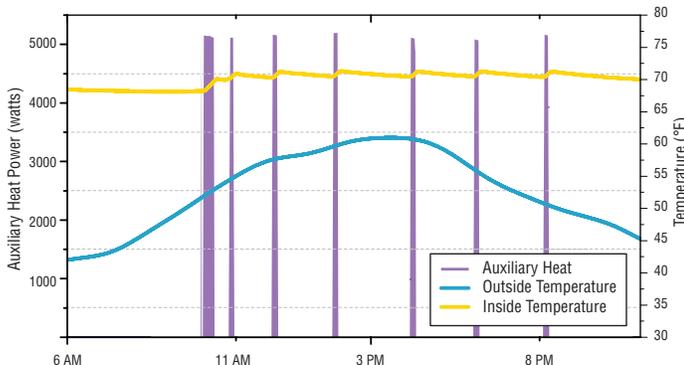
Figure 3. Auxillary heat power consumption compared to outside temperature. Strip heat power consumption (purple line) on a day when outside temperatures (blue line) never fell below 42°F.

- Through circuit-level monitoring, it was discovered that the back-up strip heat was turning on when the outdoor temperature exceeded 40°F (Figure 3)

**Under these conditions, the back-up strip heat operated throughout even moderately cool days and accounted over 20% of Greenstone's total annual energy use.** This presents further opportunity to save on energy costs.

- Replace thermostats with thermostats designed to function with a heat pump and built-in algorithms to minimize electric strip heat activation.
- Configure existing thermostats to trigger back-up electric strip heat only at exterior temperatures less than 40°F.

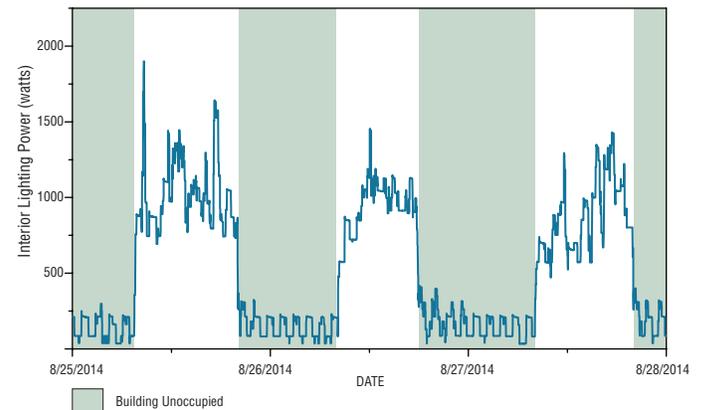
Figure 4. Total interior lighting power with spikes highlighted during several evenings when the building is unoccupied.

Sixteen percent of the building's lighting energy consumption occurred when the building was unoccupied. Data indicates lights are turning on and off when the building is unoccupied (Figure 4), possibly due to falsely triggered occupancy sensors.

- Conduct an evening walk-through to identify lights left on or falsely triggered.
- Retrofit occupancy sensors with vacancy sensors to prevent false triggers.
  - » Vacancy sensors= Manual ON; Auto OFF
  - » Occupancy sensors= Auto ON; Auto OFF
- Avoid placing sensors within 6 feet of air vents (Air flow may cause false triggers).
